Thirsk Dam and Spillway Rehabilitation

Summerland, BC

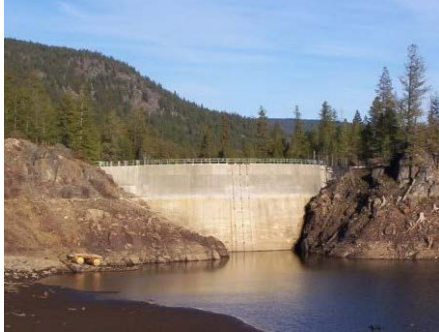
The newly expanded dam, viewed from

Following the dam safety appraisal, the District retained Associated Engineering to undertake detailed design, prepare cost estimates, complete contract documents, and provide contract administration and construction inspection services for raising and rehabilitating Thirsk Dam. The Thirsk Dam is a reinforced concrete arch dam. Prior to construction, the dam was 21 m high, had an 8 m spillway, and impounded 3200 ML of water in Thirsk Reservoir. The upgraded dam provides an additional 2500 ML of storage in the reservoir.

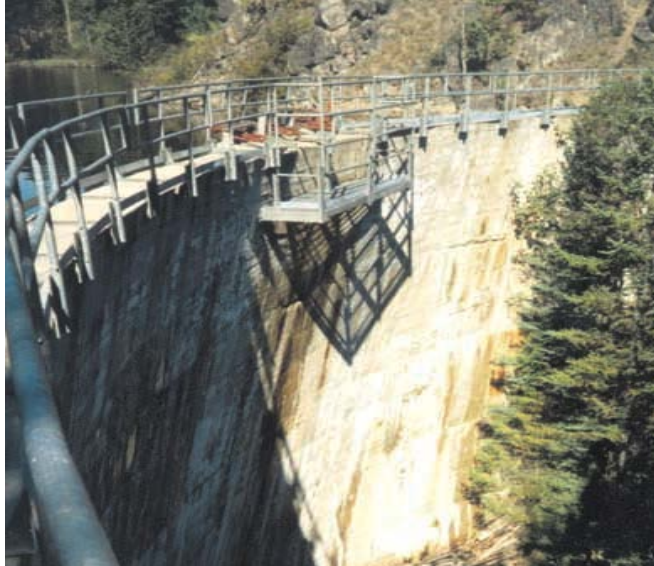
Original dam viewed from downstream.
